# **SAMPLE REPORT**

## **A Qualitative Infrared Thermo Graphic Survey Of Electrical System Components**

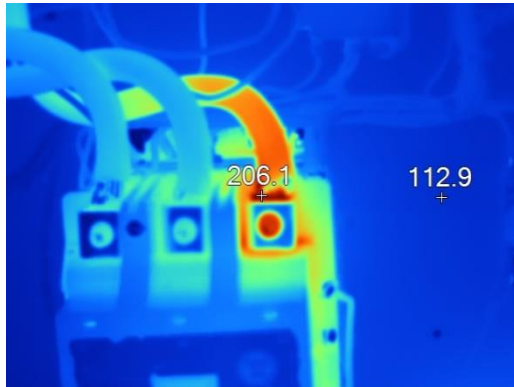
- **CLIENT:**
- **LOCATION :** West Well Field Pumps
- **AREA 1 :** West well Pump #22
- **EQUIPMENT NAME :** 300- Line Contactor Nima size 4

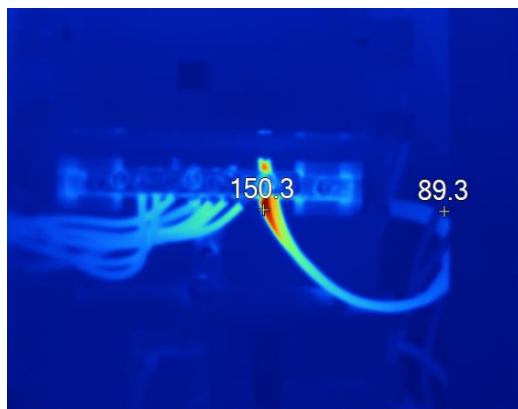
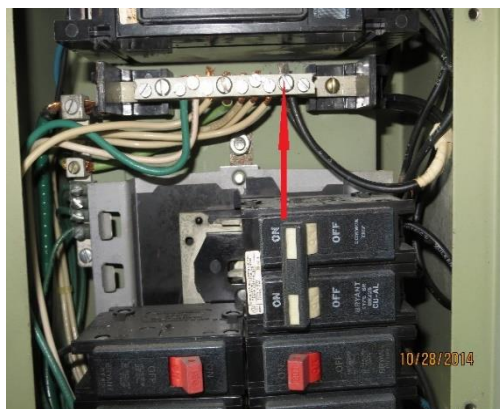
- CLIENT:
- LOCATION : West Well Field Pumps
- AREA 1 : West well Pump #22
- EQUIPMENT NAME : LIGHTING PANEL NEUTRAL CONNECTION
